Biomass Reactor

Gas Cylinder With Can Test #3

Author	Date of Last Edit & Publish	Document Version
Engineer88	19/02/2015	a

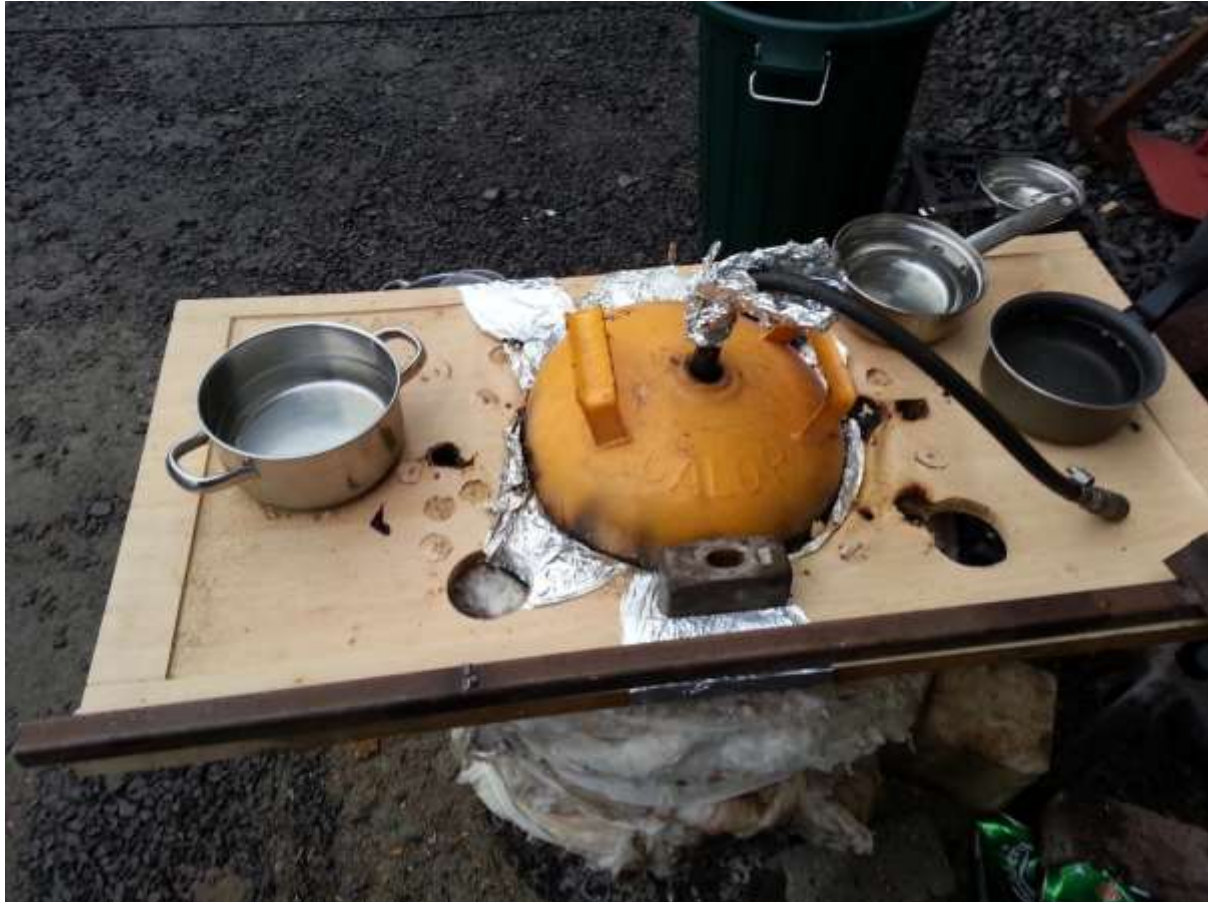
In Experiment #2, the foil covered wooden board used as a cover was heated significantly, to the point of destruction. To prevent this, in Experiment #3, saucepans (Fig 2.1) were filled with water and placed on top of the board in an effort to limit the maximum heat build-up within the wood.

Fig 2.1 Photograph showing the physical state of the reactor after the experiment was completed

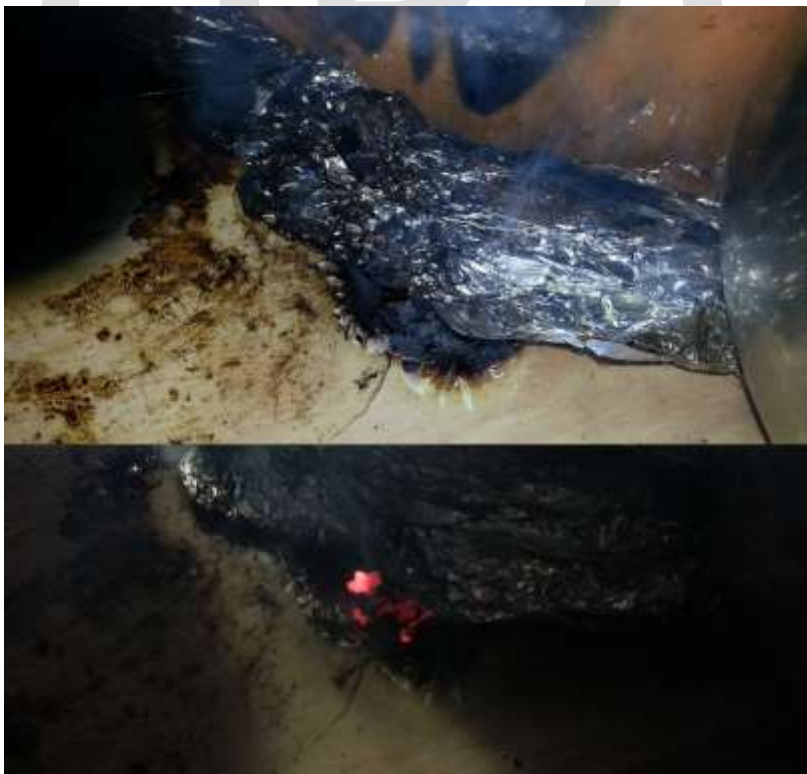
Fig 3.2 Photograph showing the cover board glowing red hot before being extinguished with water
