Bio-Mass Reactor

Gas Cylinder with Can Test 2

Second Test of Welded Can Inside Gas Bottle

Experiment 25/01/2015

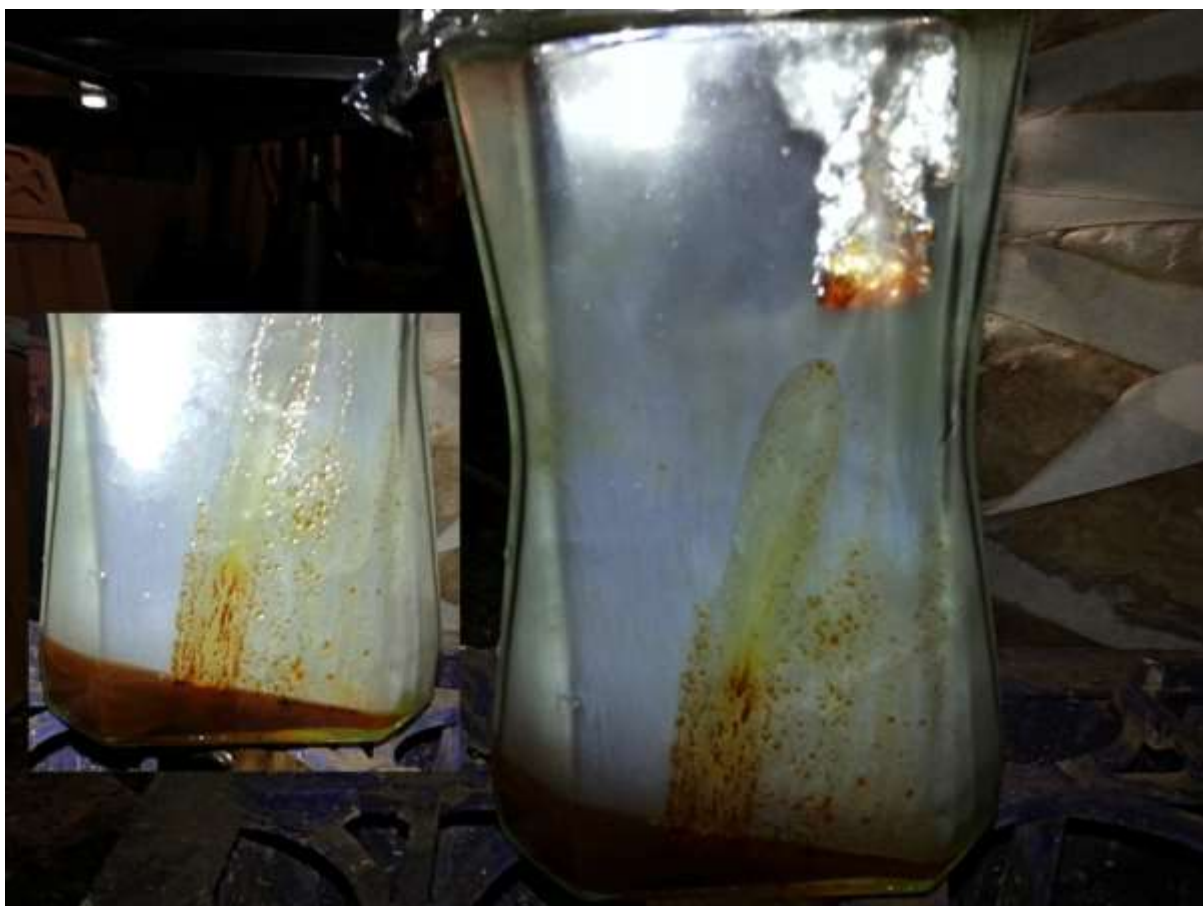
Fig 4 – Image showing the fumes exhausted from the internal can and the oily substance that has condensed from them

- The foiled wooden board is an insufficient cover. The heat damages the material, it poses a fire risk and it is not an efficient insulator (there is still heat loss).
- Flow at the cyclone filter was not visibly significant. There is no evidence of a cyclone effect, fumes only visibly exhausted from the bottom.
- Fluid heat was lost at the hose. There was a significant temperature difference at either end of the hose, radiant heat was felt.
 - The fluid that dripped from the female connection when the hose was disconnected is a sign that the setup was acting more like a condenser. In the demonstration from ASU, they collected a less viscous substance from the cyclone filter. They collected a visually similar product to what is shown in Fig 4 from a separate condensing unit, a stage beyond this reactor.

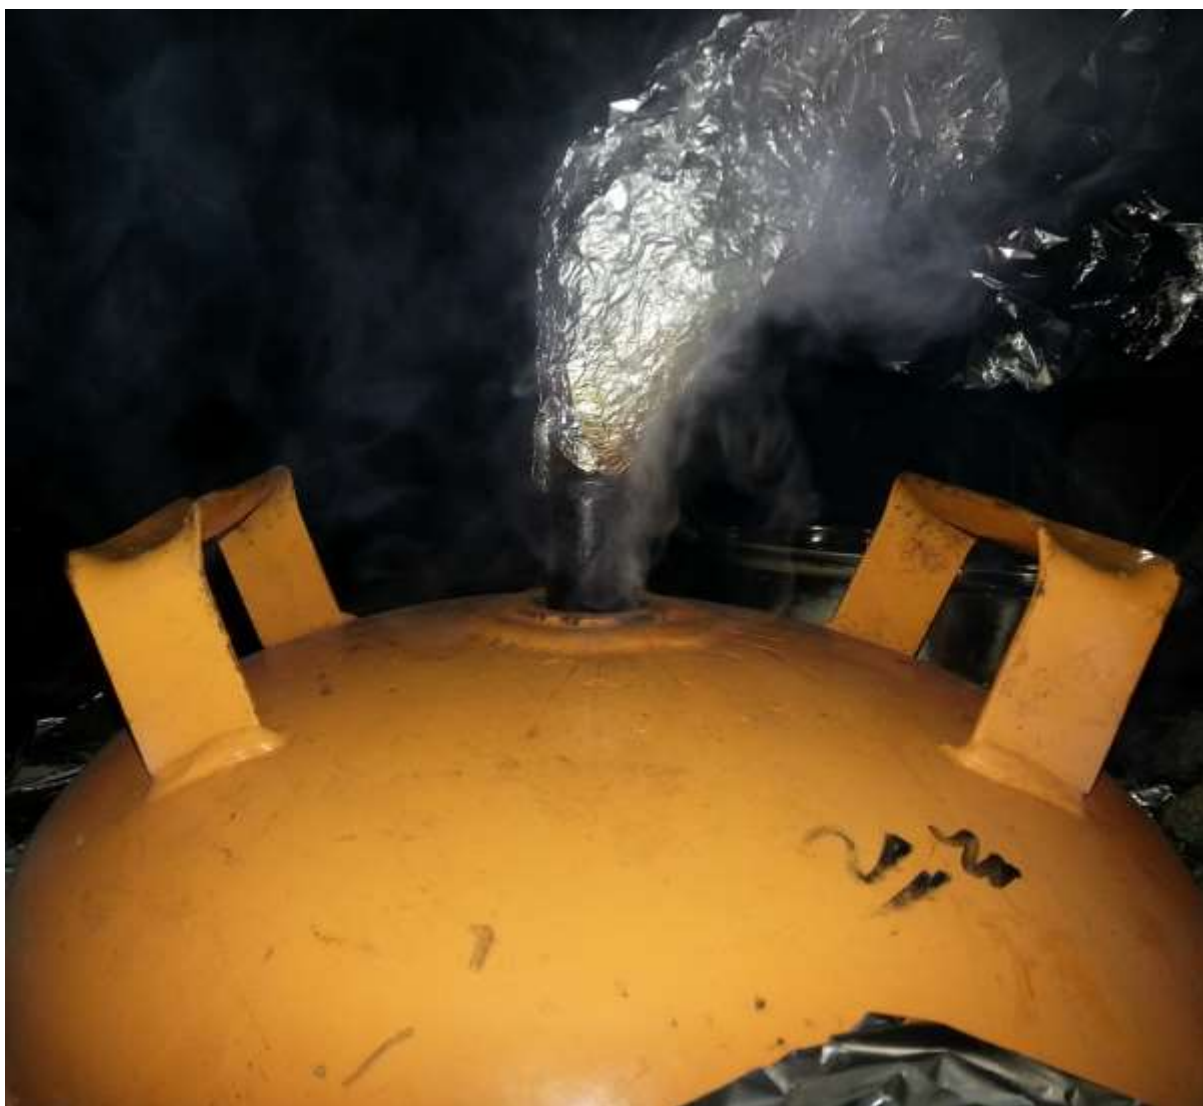
Fig 5 – Image showing the acrid smoke that was released from inside the gas cylinder. Note the discolouration of the internal can's exhaust pipe. It is a heavy black residue.

1h 35 min	<ul style="list-style-type: none"> • More smoke & fumes are escaping at the gas cylinder neck. (Fig 5) <ul style="list-style-type: none"> ○ Bursts of wind make the flame flutter
1h 45 min	<ul style="list-style-type: none"> • Smoke escaping from neck is becoming constant – Is this the beer cans? (Fig 5)
2h 0 min	<ul style="list-style-type: none"> • Hose is no longer warm. Why? <ul style="list-style-type: none"> ○ Disconnected the hose from the cyclone filter. Some (not hot) fluid dripped out from the female connection.
2h 8 min	<ul style="list-style-type: none"> • Moved the cyclone filter so that the hose no longer sits up hill (Fig 3)
2h 15 min	<ul style="list-style-type: none"> • Fumes have started leaving the bottom outlet of the filter. (Fig 4) <ul style="list-style-type: none"> ○ Fumes are thick and contain an oily substance
2h 40 min	<ul style="list-style-type: none"> • Considerable smoke is escaping from the gas cylinder neck. – Unpleasant and irritating, requires a respirator. (Fig 5) • Rain is starting • Gas cylinder paint is peeling – Signs of glowing red hot

3h 0 min	<ul style="list-style-type: none"> • Escaping smoke is acrid. Burns eyes and absolutely cannot breath without a respirator. (Fig 5) • Retreating inside for a break and to avoid the smoke
3h 50 min	<ul style="list-style-type: none"> • Fumes from internal can – that leave the cyclone filter – have reduced significantly • Fumes escaping from gas cylinder have reduced significantly • Burner gas (propane) is turned off • Cyclone filter disconnected - thus sealing the internal can • Experiment ended

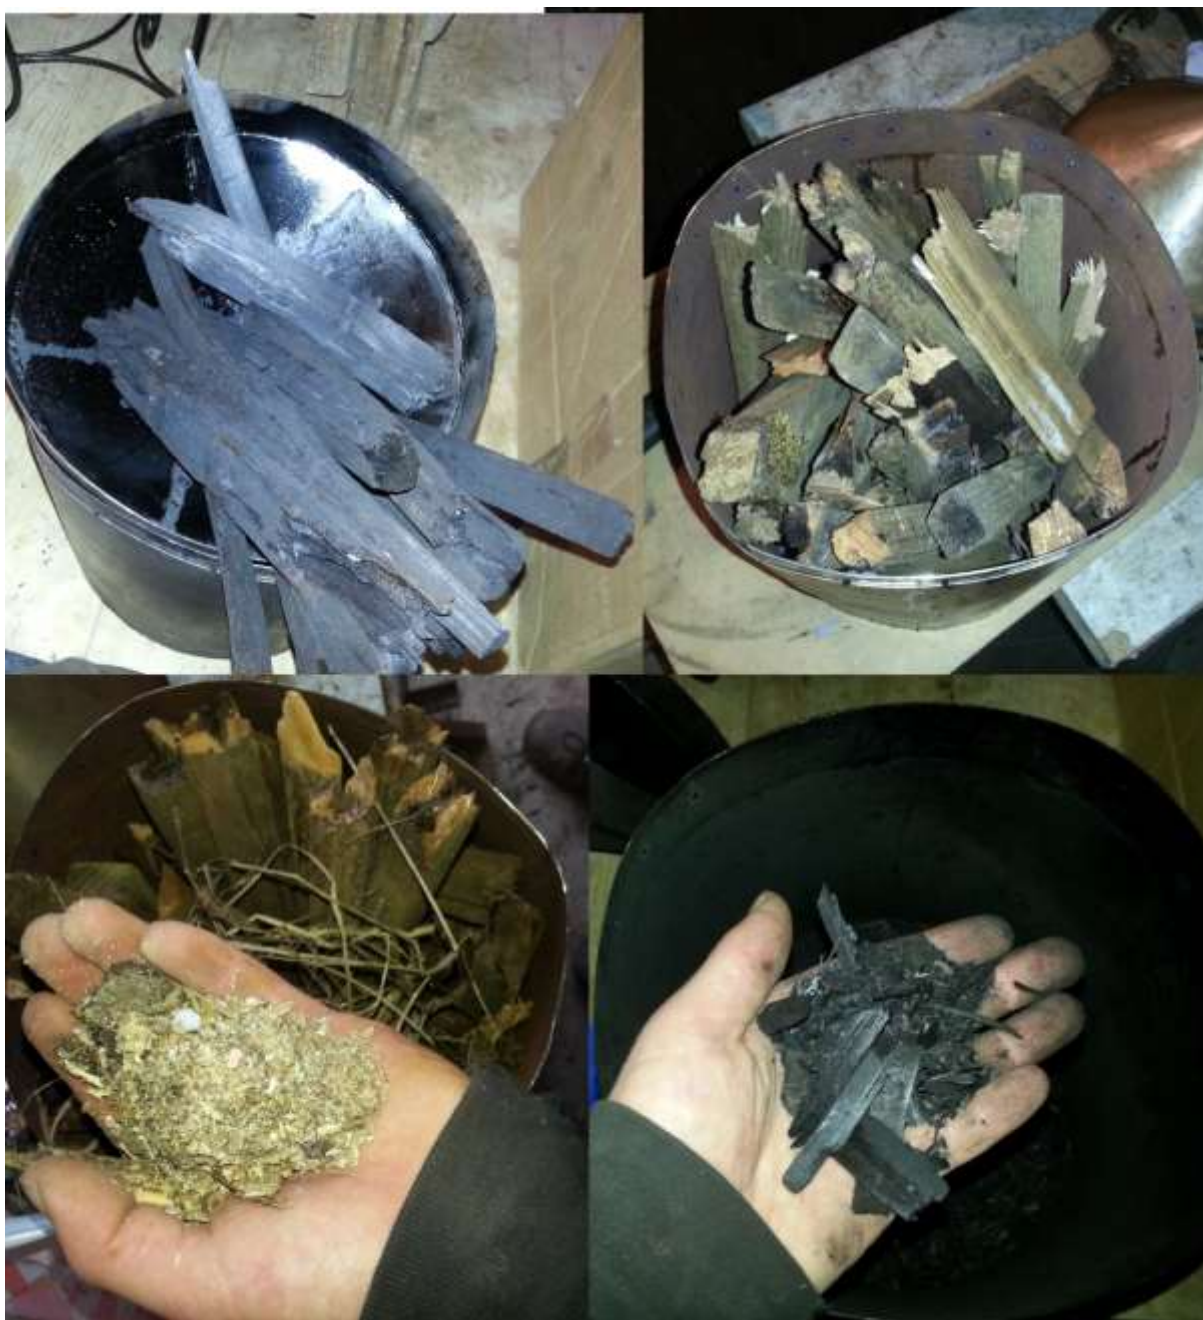
Fig 6 – A comparison of the materials before and after the reaction.

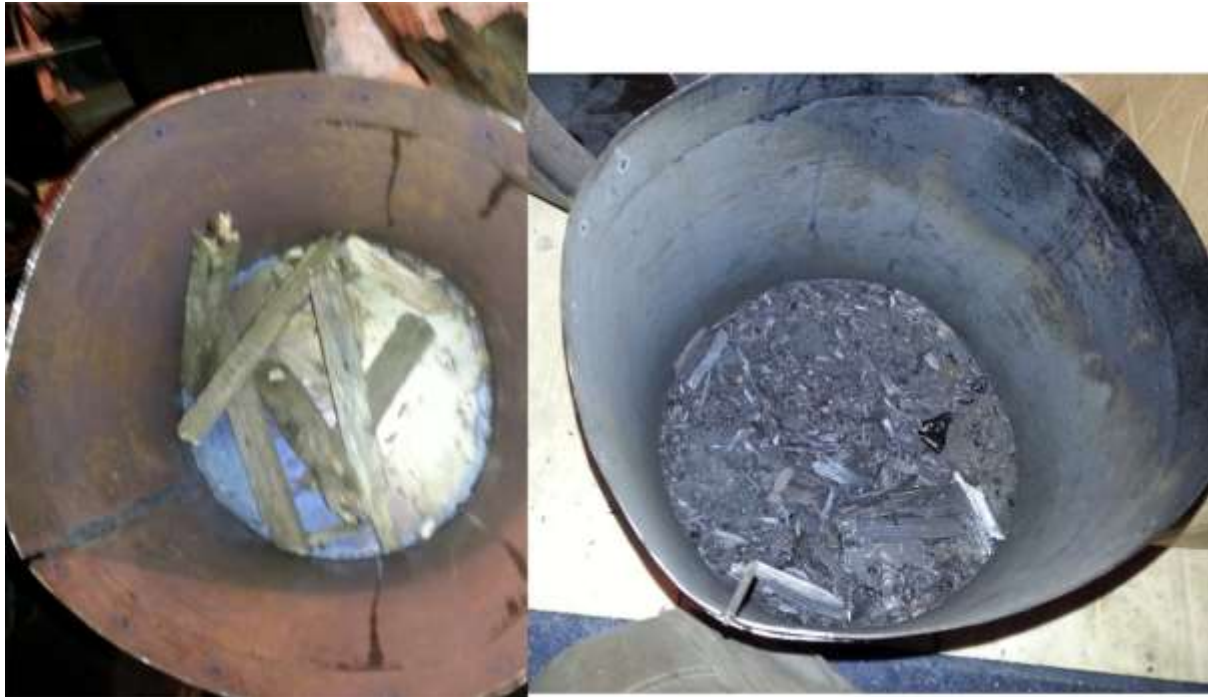
Fig 7 – Image comparing the internal can's surfaces. (Left is Experiment #1 – Right is Experiment #2).

After experiment #1, surface rust remains on the can with a very localised discolouration on the can's base.

In contrast, after experiment #2, the surface rust has been removed entirely from the can. There is discolouration around a portion at the top of the can; there is no immediate explanation for this discontinuity in uniformity.

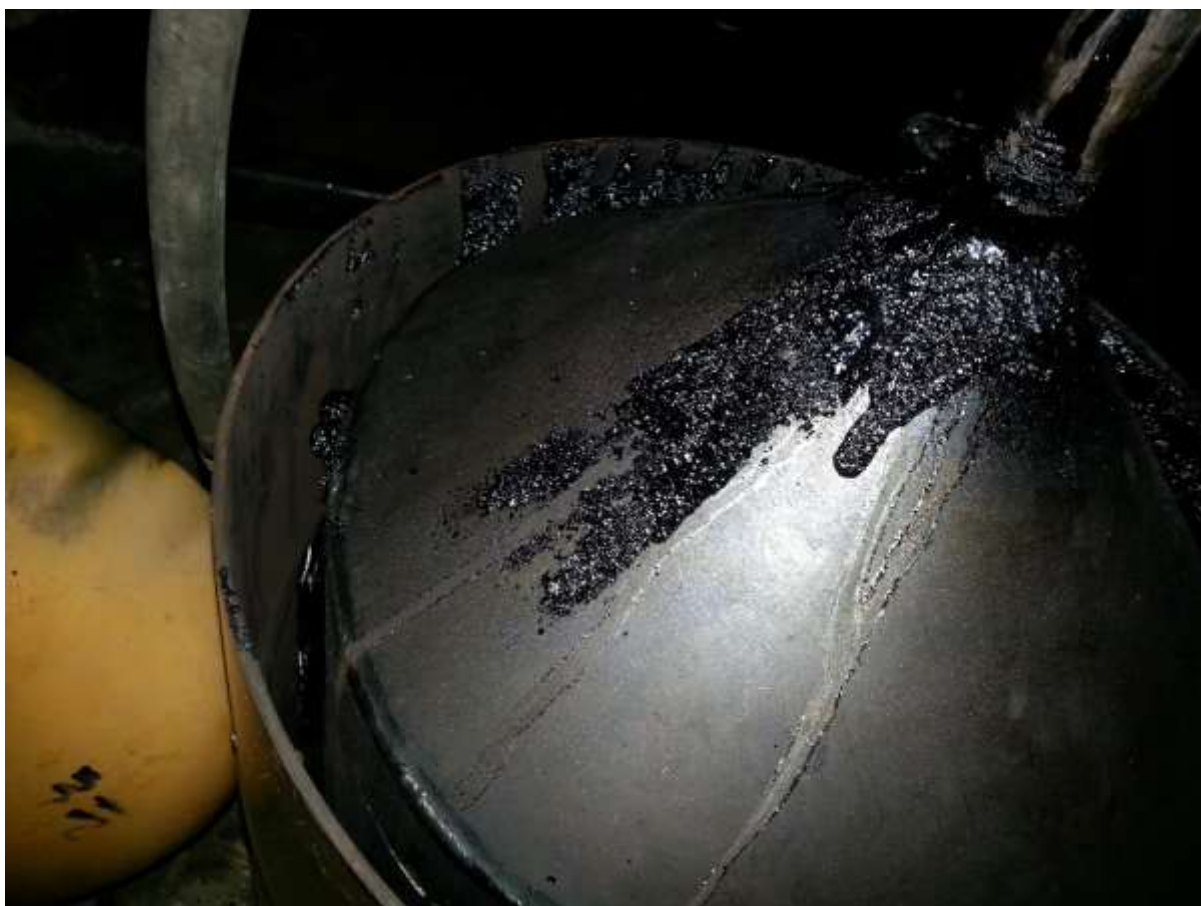
Fig 8 – A low density charred product was found in the cavity between the gas cylinder and the internal can. It feels like very low density expanding foam and is very brittle – it will grind into small particles if not handled very gently.
